Forest Insect & Disease Management

Report No. 79-1-20
May 1979

PREVENTATIVE MEASURES TO PROTECT HISTORIC STRUCTURES:

A CASE HISTORY OF THE HENSLEY SETTLEMENT

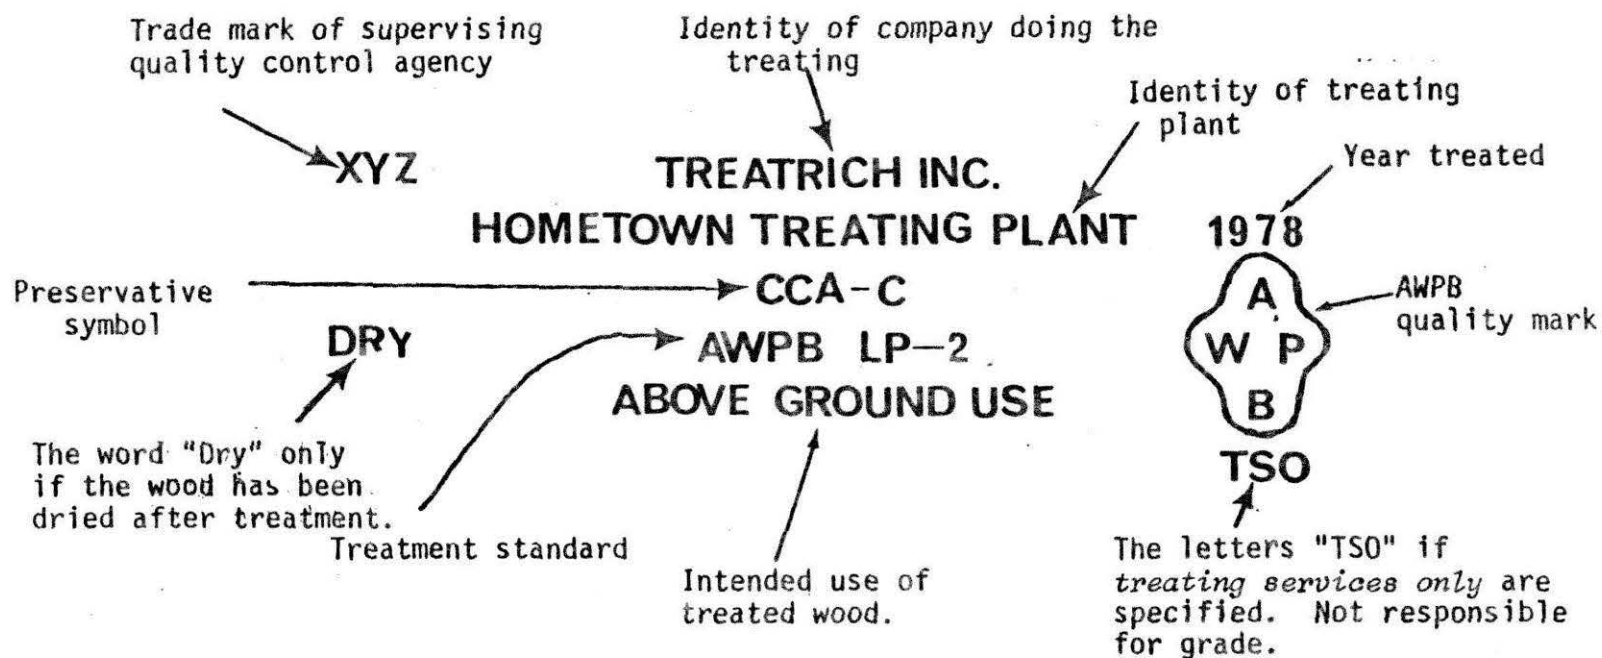
Figure 1.--AWPB Quality Stamp.

Select treated wood that has a quality mark, tag or brand. The quality mark indicates that the wood meets strict quality control standards. The American Wood Preservers Bureau (AWPB) inspects the wood and, if standards are met, marks it accordingly (figure 1). Creosote and penta treated wood usually do not carry a quality mark, but may be branded or tagged. In any case, ask for proof that the wood was treated to meet standards. The quality stamp or proof of treatment should contain the name of the treating company, the preservative used, the standard to which the wood was treated, and the intended use of the treated wood. Again, use treated wood for its intended use. If the quality mark is for above ground use, the wood will not serve well in ground contact. If the wood is marked for ground contact use, it will also serve well above ground but the cost is higher than that treated for above ground use. Any wood used in the foundation of a building must carry the AWPB-FDN (FDN=foundation) quality stamp. The preservative retention of FDN treated wood is higher than that of wood treated for other kinds of ground contact. It will lend added protection to the difficult-to-replace wood in a foundation.

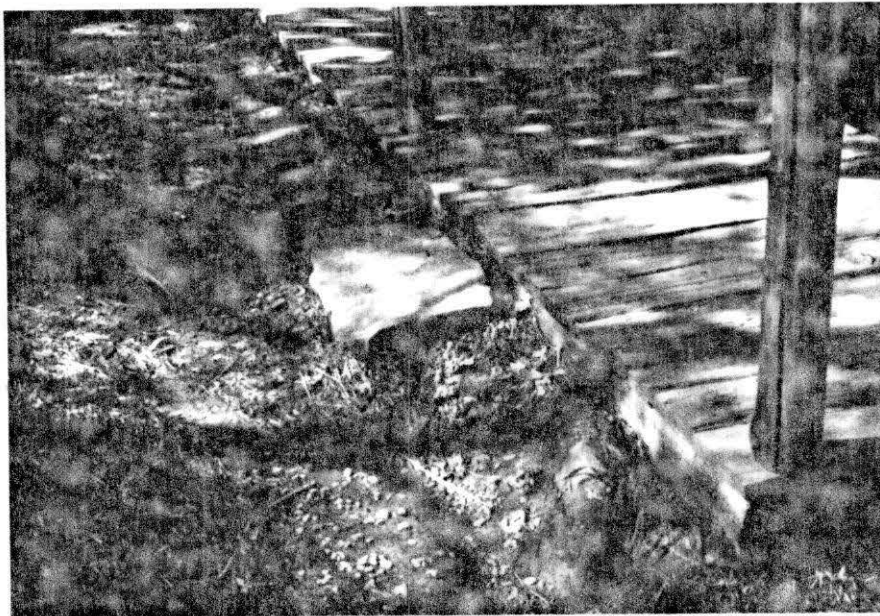
This building rests too close to the ground. The outer porch sill log is partly buried in the soil (figure 2). The sill has a moisture content exceeding 30 percent and is beginning to decay. Decay will also destroy the floor boards that rest on this sill.

Figure 2.--Outer porch sill is in contact with the soil.
Contact with soil should be broken.

It is not practical to raise the porch sills and the floor;

therefore, drainage around the house should be improved to divert water away from the building. A wide, gently sloping ditch should be dug at the front of the porch. The grade should slope away from the porch. The ditch will divert water that previously ran under the porch from the hill above the house. The runoff from the porch roof will also be diverted from the building.

In addition, the soil from the front and underside of the sill should be replaced with stone piers. These changes will remove a source of moisture and improve the ventilation under the porch.

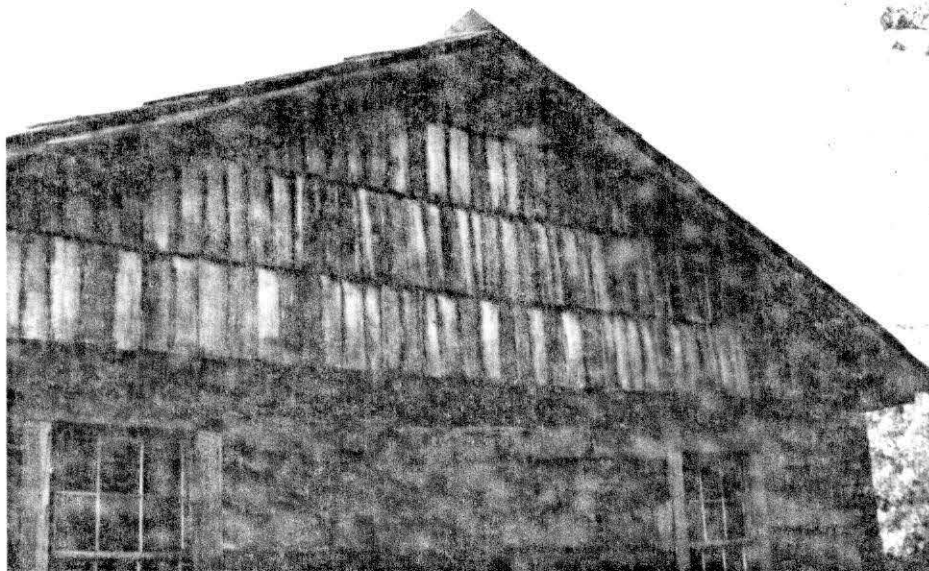
The end grain of the top front and rear wall logs is exposed (figure 3). The end grain absorbs moisture faster than the grain in any other dimension. In this case, the ends are directly exposed to rain and may begin to decay. If they are not actually functioning as support for the floating rafters, they should be trimmed back to the wall.

Figure 3.--Exposed end-grain of top wall logs will absorb moisture. The ends of these logs should be sloped back toward wall, or trimmed flush with other log ends, if not functional.

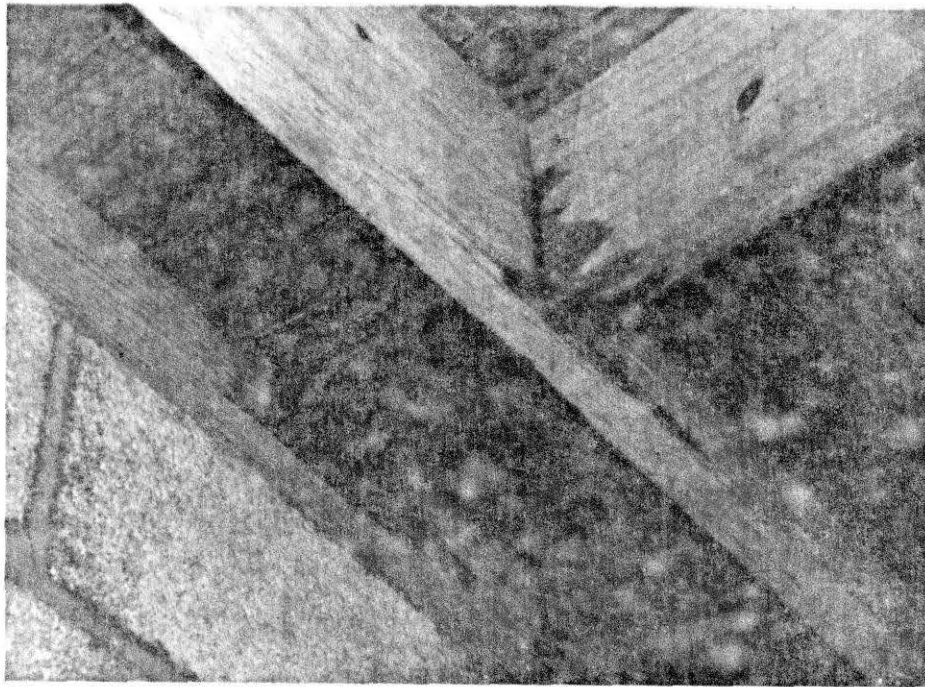
Two items that should have been installed when the house was rebuilt were pressure treated sill plates and termite shields. The existing untreated sills are subject to insect attack and decay in their moist environment (figure 4). Termite shields, even though they can be bridged by the insects, can force them to a surface where their mud tubes can be observed.

Figure 4.--Flooring and framing are wet. The source of moisture is a roof-chimney joint that should be flashed. The sill should have been of pressure treated lumber.

The chimney should be flashed at its junction with the roof. Runoff from the roof flows down the chimney and finds its way into the floor and framing below. The chimney should also be covered with a loose or tight cap depending on whether it is to be used. Water should not be permitted to run down into the firebox.

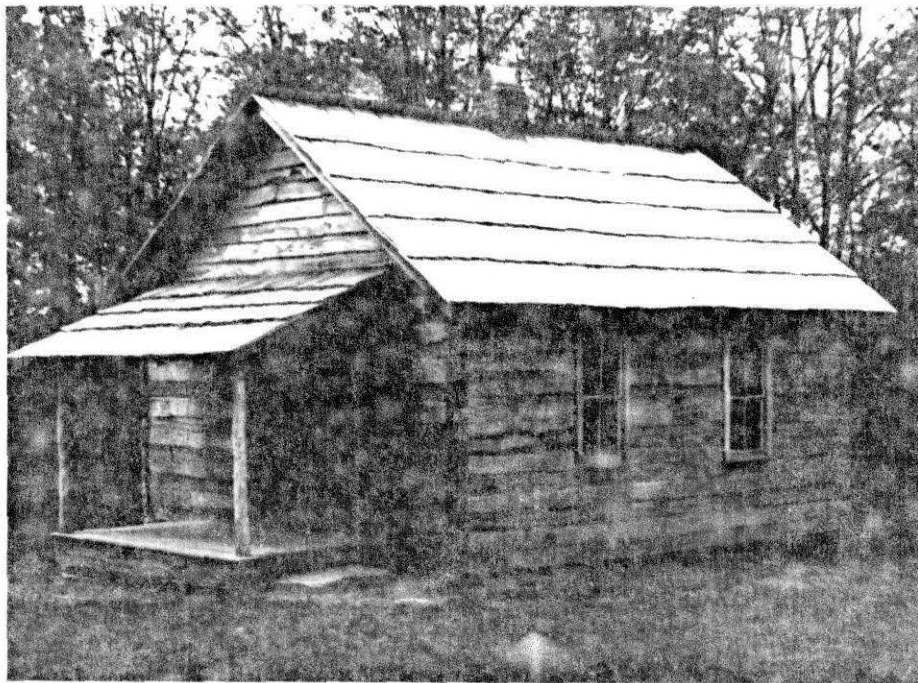
Overall, the school house is in fairly good condition. Some sill logs are closer than 12 inches (30.5 cm) to the soil. However, the building has adequate clearance for most of its perimeter and good ventilation in its crawl space (figure 5). Drainage is also good.

Figure 5.--The crawl space of the schoolhouse is well ventilated both by height above ground and lack of solid underpinning. Note also, absence of flashing at juncture of porch roof and front wall.

The juncture of the porch roof and house wall should be flashed. Raise this siding 2 inches (5 cm) above the shingles and insert metal flashing that will extend under the shingles and siding. This may be difficult but should be considered if there is reason to do any work on the roof in the future. The roof of this building was not inspected. However, stains on the ceiling indicate a present or past leak in the roof or upper walls (figure 6). All leaks should be stopped.

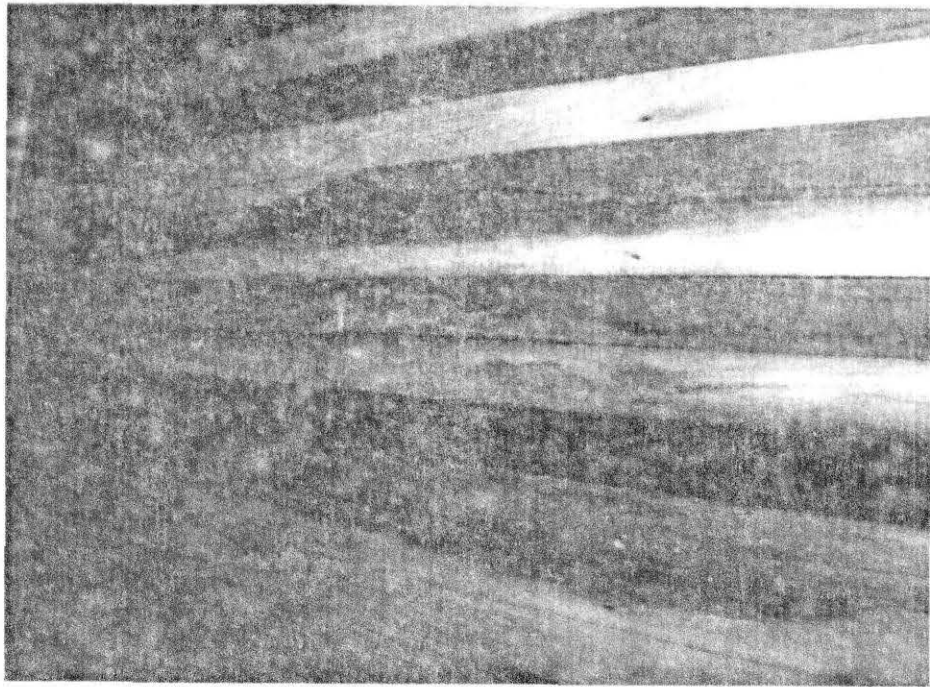
Figure 6.--Water stains on the ceiling of schoolhouse.
The source should be located and the leak repaired.

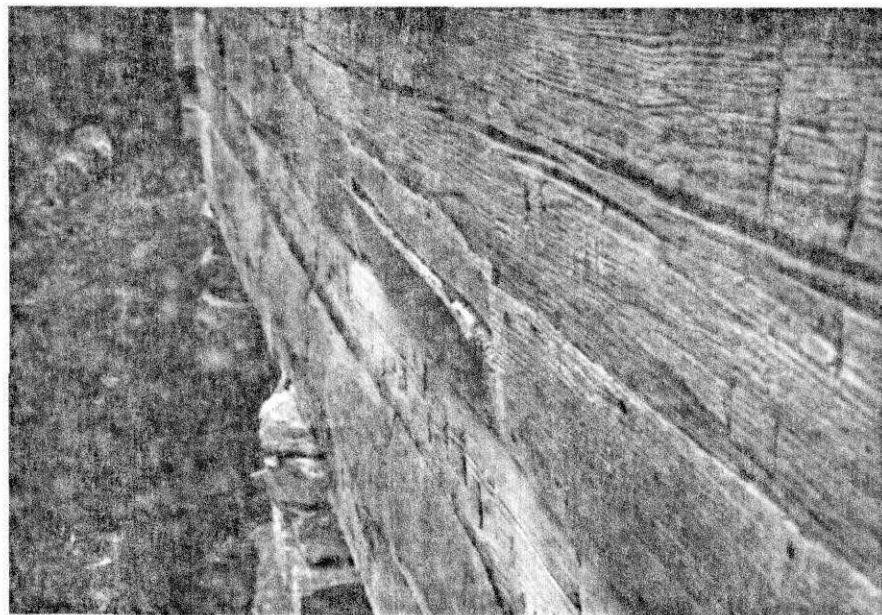
The clay based mortar between the logs could become a source of trouble (figure 7). Wood should be kept dry. Walls

Figure 7.--Mortar such as this can trap and retain
water. Perhaps it should have been omitted.

constructed like this one can trap water in the mortar behind the log battens. Once trapped, the wood will dry slowly and decay can proceed. Perhaps, in the future, buildings should be reconstructed without this water-trapping and holding material.

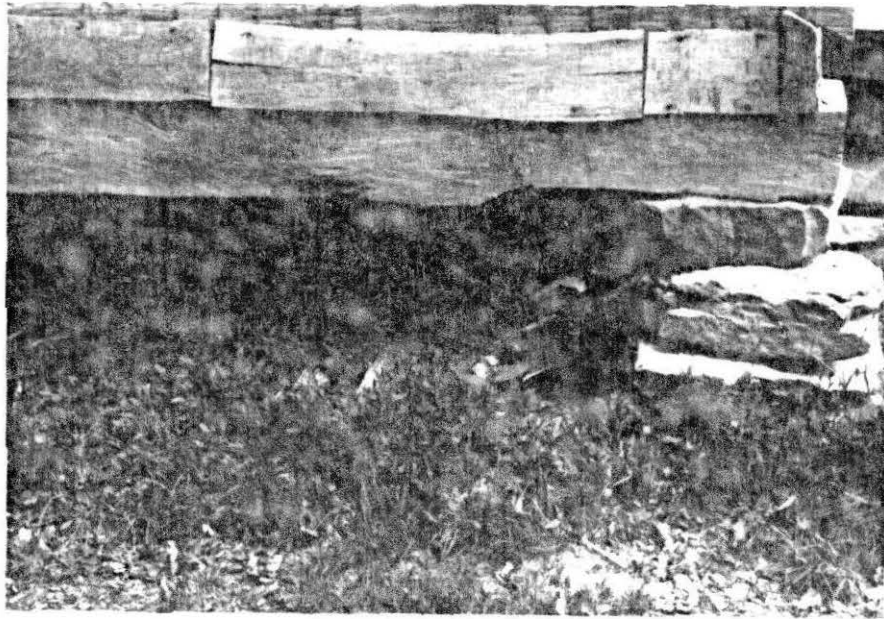
Figure 8.--Wood debris stored under the schoolhouse.
Material like this attacks wood-destroying
insects to the building.

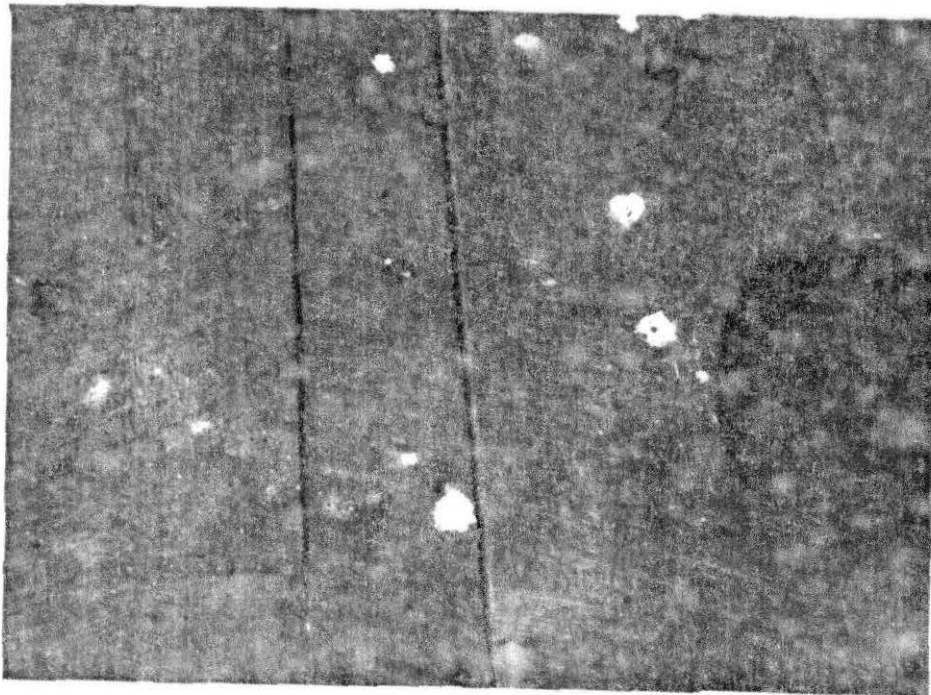
The seat in the outhouse, southwest of the school house, contains active beetles (figure 9). No chemical control is recommended, since the seat can be easily replaced when necessary. This building is also too close to the ground and is poorly drained (figure 10).

Figure 9.--Piles of fresh sawdust demonstrate the
presence of active infestations by beetles.
In this case, replacement of the seat would
be more appropriate than chemical treatment.

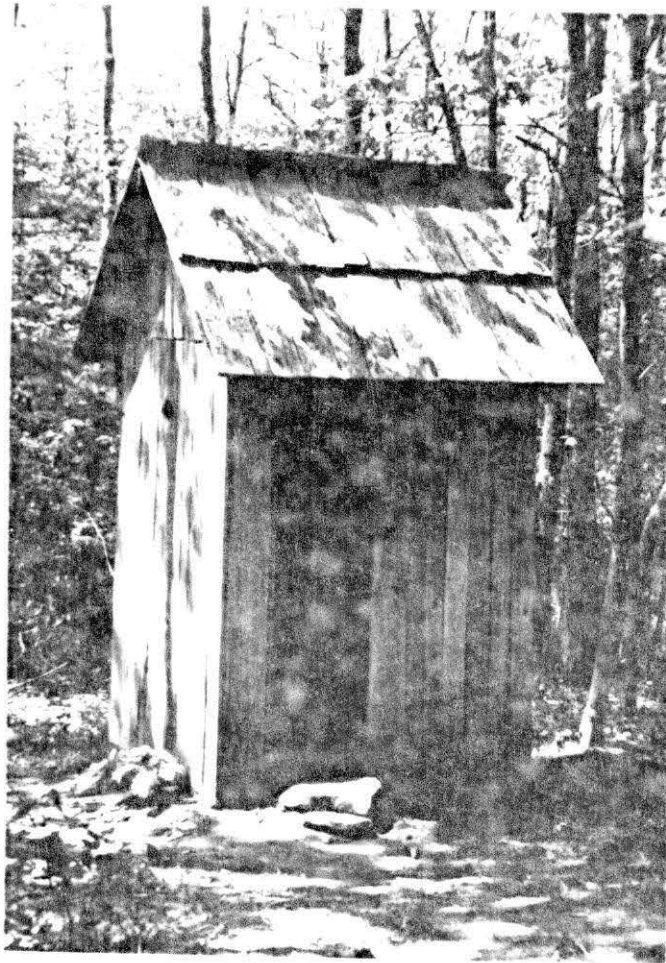
Figure 10.--The school outhouse is too close to the ground.

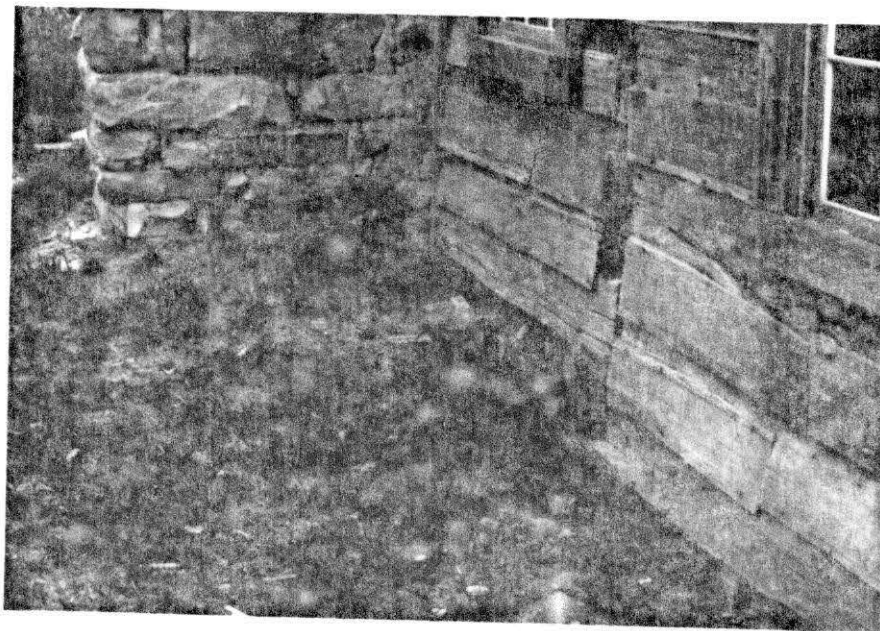
House. -- The northern end of the house is too close to the ground (figure 11). The soil should be removed from the sides and underneath sills where there is contact. The sills should then be placed on stone piers. A full 12-inch (30.5 cm) separation of wood and soil will involve a larger excavation project. A wide gently sloping drainage ditch should be dug

Figure 11. Wood sills are within 12 inches (30.5 cm) of the soil. Soil should be removed and wood members placed on stone piers.

at this end of the house. The grade should slope away from the house. A ditch built in this way will also have to be kept free of debris, soil fill, and vegetation other than grass.

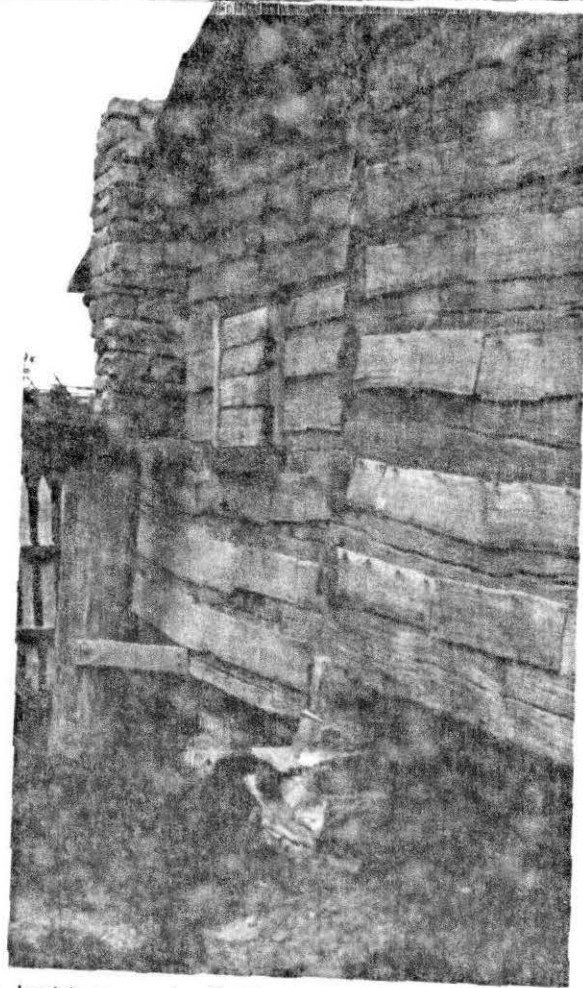
The chimneys should be flashed and capped. The wood support post for the kitchen chimney (figure 12) should be raised off the ground. This could be done now, or when the post has to be replaced.

Figure 12.--The bottom end of the wood support post for the kitchen chimney will probably decay, with time. It should be set higher off the ground on stone.

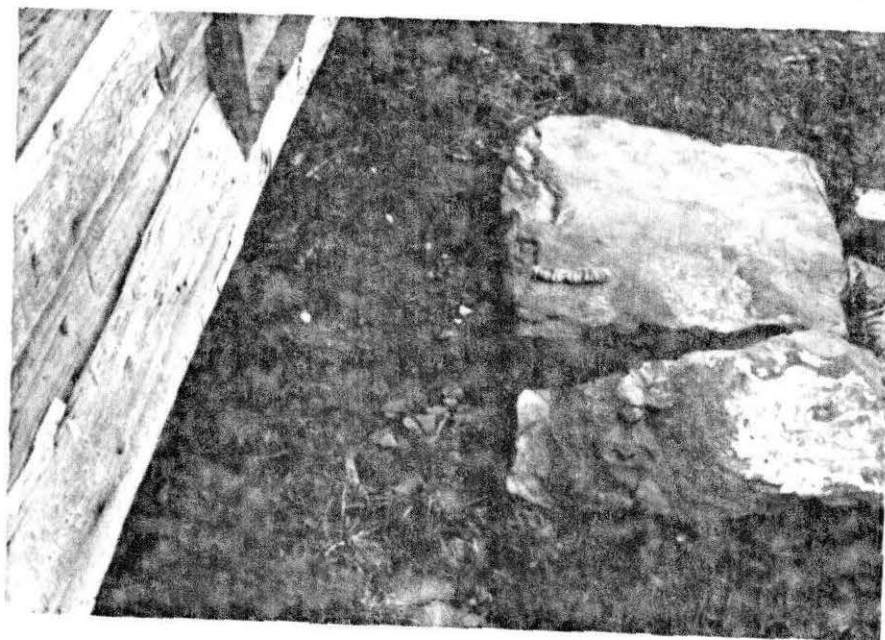
The stepping stone at the kitchen door was moved as recommended (figure 13). Previously, rain running off of the kitchen roof splashed from the stone to the sill log. The log became wet and had begun to decay. By removing a source of water, the log should stay drier and last longer.

Figure 13.--Stepping stone at the kitchen door. It is now away from the drip line. As a result, the sill above will remain drier. Notice decay fungi fruiting bodies that were removed from the sill.

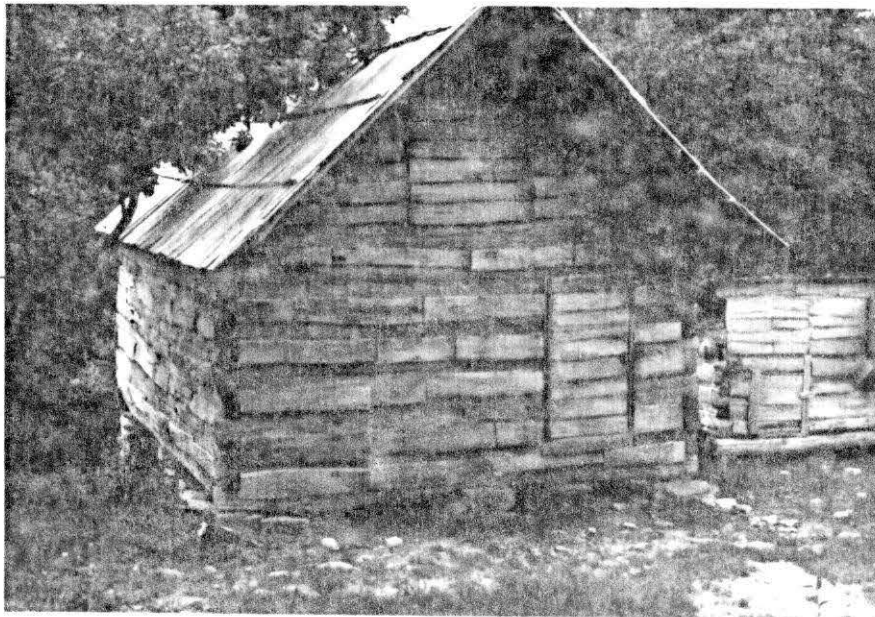
corncrib and barn, are too close to the ground (figure 14). The center sill of the barn (figure 15) has begun to decay. Only a reduction in moisture content will slow the decay. Raise the building 12 inches (30.5 cm) above the ground on stone foundations or piers.

Figure 14.--The corn crib is too close to the ground.

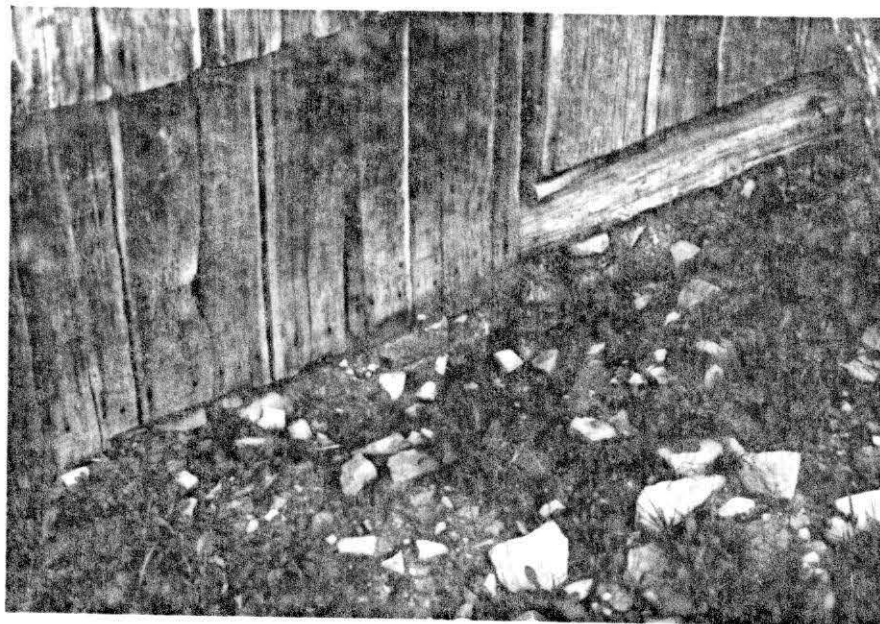
Figure 15.--The center sill of the barn is against the ground. It has begun to decay. Soil should be removed from around it and should be placed on stone pier.

Careful, annual inspections will also be required for termites in these sills. Continued contact with the soil provides the best possible conditions for their attack.

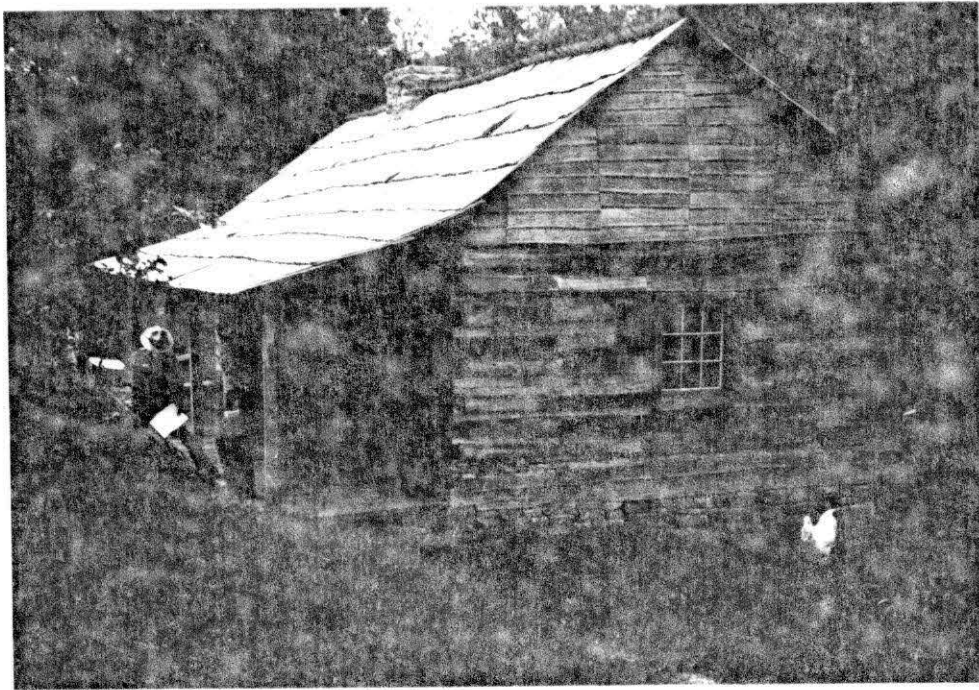
House. -- The drainage needs to be improved at the front of the house between the porch and the bank. Again, provide a gently sloping ditch at the front of the house to divert water away from the house. Run-off from rain and snow, and the presence of active springs, permit water to run under the porch (figure 16). Subsurface drains, such as perforated, plastic pipe, can be used to carry spring water along the bank and past the end of the house. The chimney of this structure needs to be flashed and capped. See figure 17. Some tar was apparently used to seal the joint on the east side at the juncture of the roof. It should be inspected annually, because these joints frequently leak. Snow infiltration of the attic can be reduced by closing holes

Figure 16.--Steep slope immediately in front of the porch. Drains should be provided to permit spring water and drainage to run past the end of the house.

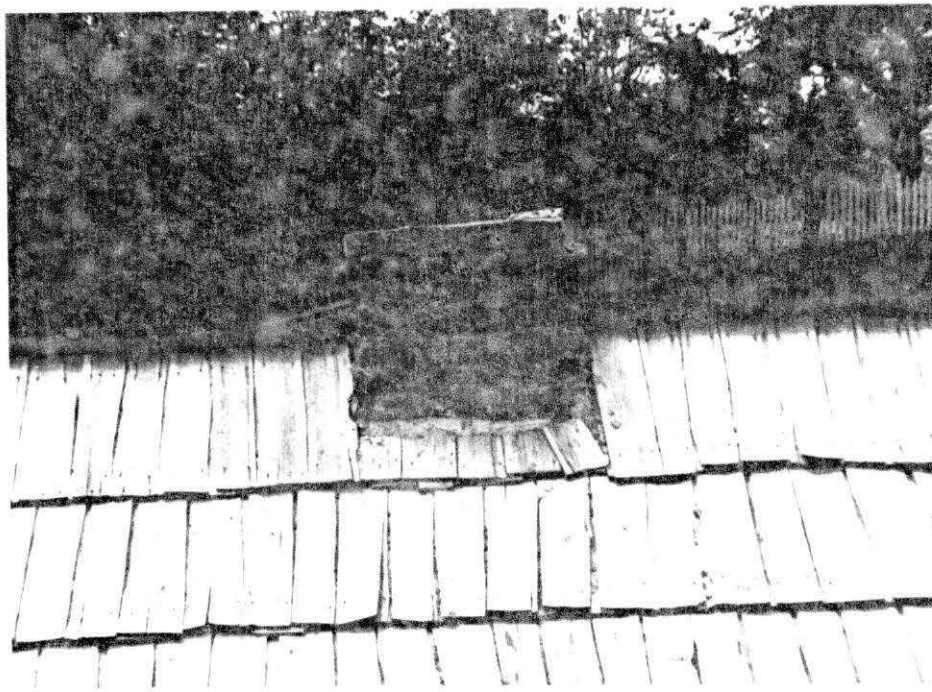
Figure 17.--Wide opening at the ridgeline. Shingles should have been laid tighter during reconstruction. Notice also the lack of flashing and the separation of the tar sealer around chimney.

and reducing drafts. Most cracks, especially in the shingles, probably cannot be sealed to wind-blown snow. Shingle roofs can leak snow but not leak rain water. If there are rain water leaks, they should be repaired. However, because of the design snow may still enter. The best solution is to winterize the structure as much as possible by closing the ridge crack (figure 17). Snow probably blows in along the ridge; block it off with a board during the winter. The ridge opening in this building seems to be wider than most. The shingles should have been laid tighter, at the time of reconstruction. If the ridge and gable cracks are closed permanently louvered vents must be installed for ventilation.

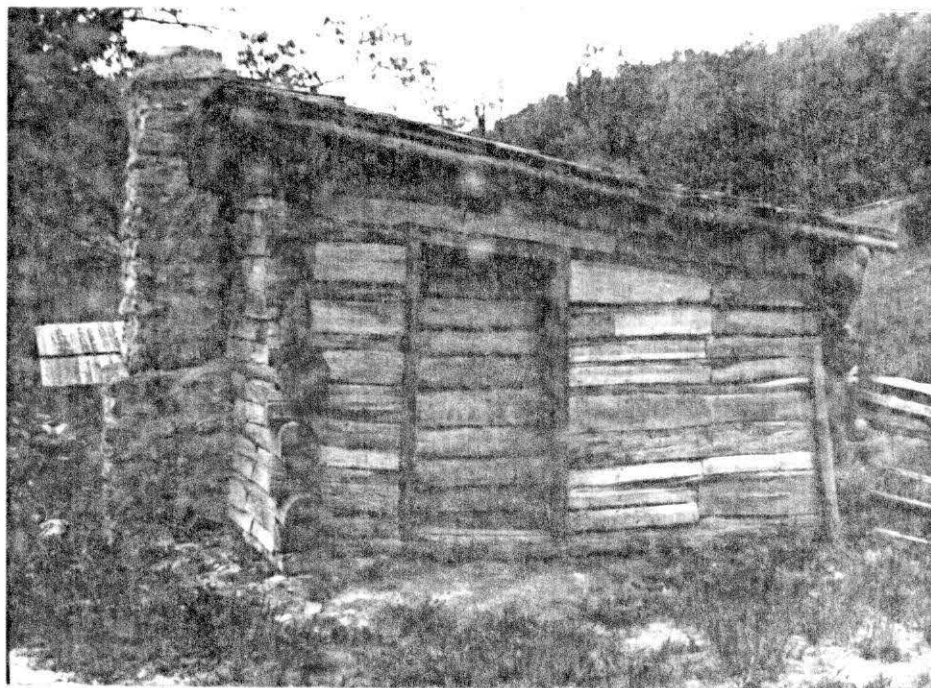
Blacksmith Shop. -- This structure has serious problems. The sill logs are on the ground (figure 18). The chimney is not flashed nor capped. The building lacks adequate ventilation. The roof leaks, and the drainage on the north side is poor (figure 19). The dirt floor of this structure is so wet that it has attracted crawfish. To correct these problems, the drainage, particularly along the road, should be improved, perhaps with a ditch between the road and the building. The roof leaks should be repaired; the chimney should be flashed and capped, and the shutters should be opened during the day to improve ventilation.

Figure 18.--Note sill logs are in contact with the soil. Raising this building would affect the chimney, so the most practical solution is to remove the soil from around the logs. Put them on stone piers.

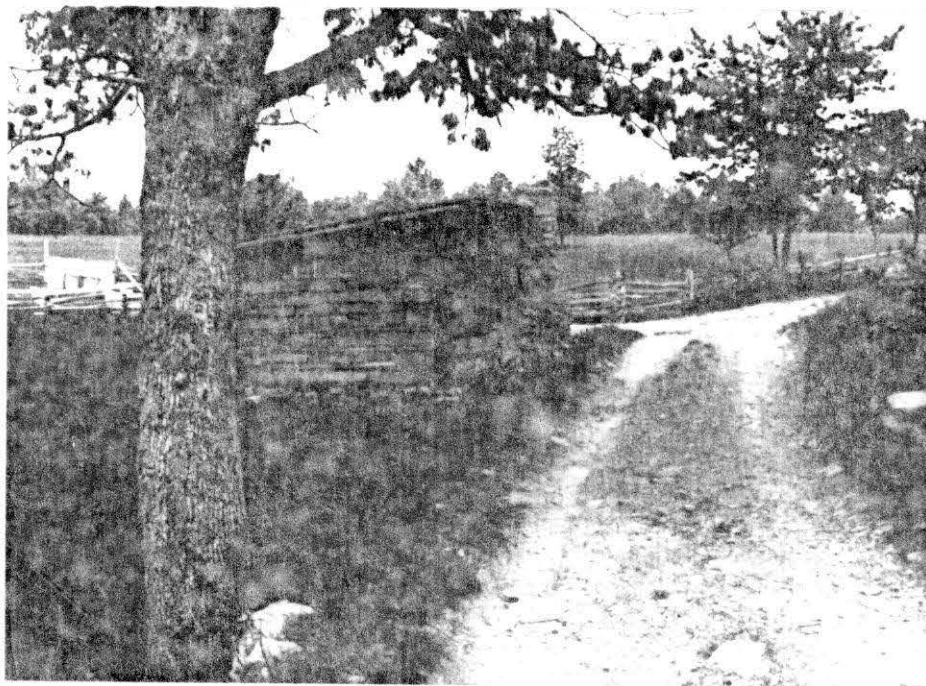
Figure 19.--Poor drainage permits silt and water to flow against the sill of the blacksmith shop. A drain along the road should be provided to move water away from the building.

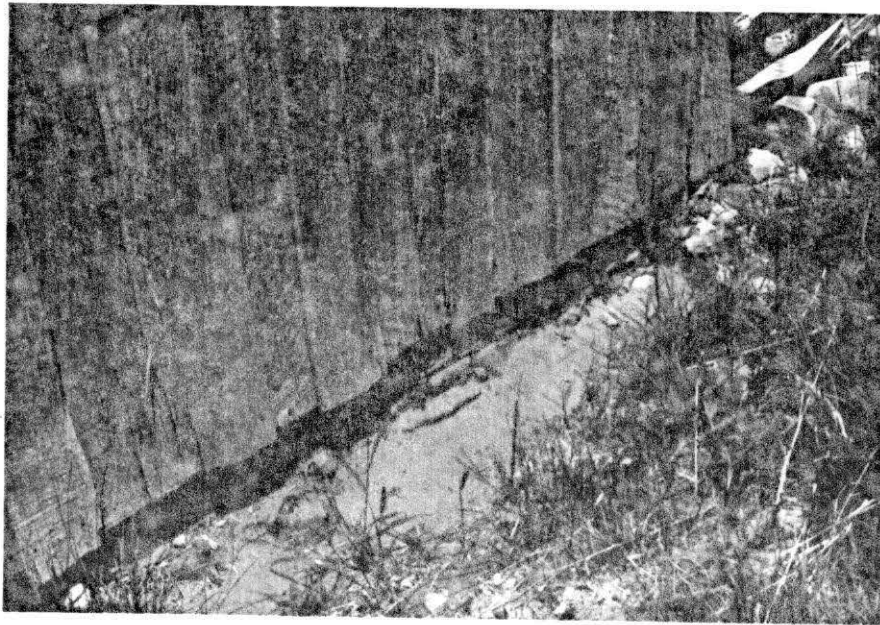
Sheep Barn. -- The sill logs rest on the ground and the drainage from the road flows through the barn (figure 20). The best methods for correcting these problems are: (1) raise the building on stone piers, (2) dig a ditch between the road and barn, and (3) improve drainage along and away from the north side of the barn. Once the building is raised, the opening can be closed with a stone wall capped with termite shields. Such a foundation was not present and may not be historically accurate. The sills will have to be replaced in a few years unless something is done to keep them dry.

Figure 20.--Sill logs are in contact with the soil.
Notice the collection of fresh silt
against sill of the sheep barn.

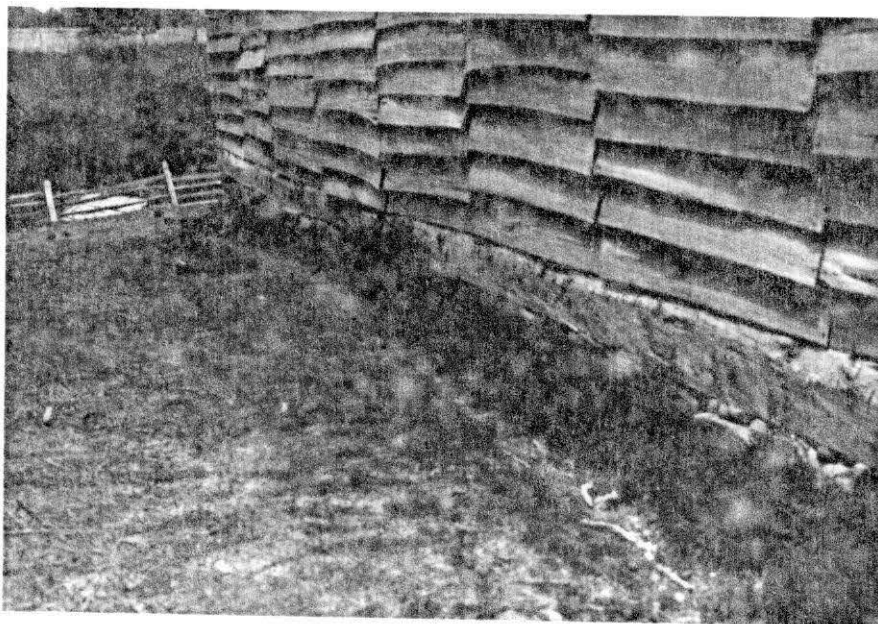
Main Barn. -- Again, sill logs are too close to the ground (figure 21). The drainage also needs to be improved on the northeast side at the drip line. Water from the roof wets the soil along the foundation. One problem that probably can't be corrected now is the lean of the building. The northeast wall is not plumb. Thus, rainwater from the roof falls close to the sill at the base of the wall (figure 22). This is another reason to plumb walls during reconstruction.

Figure 21.--Sill is too close to the ground and
subjected to splashing from roof run-off.

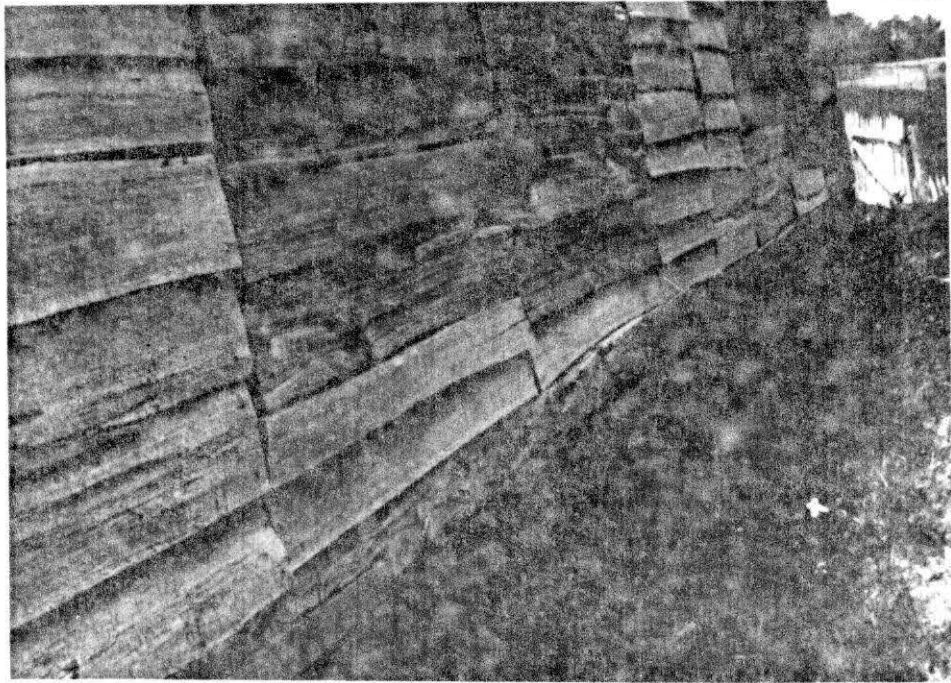
Figure 22.--Building is out of plumb, thus water falls close to the bottom of the wall. Building should have been plumb when reconstructed.

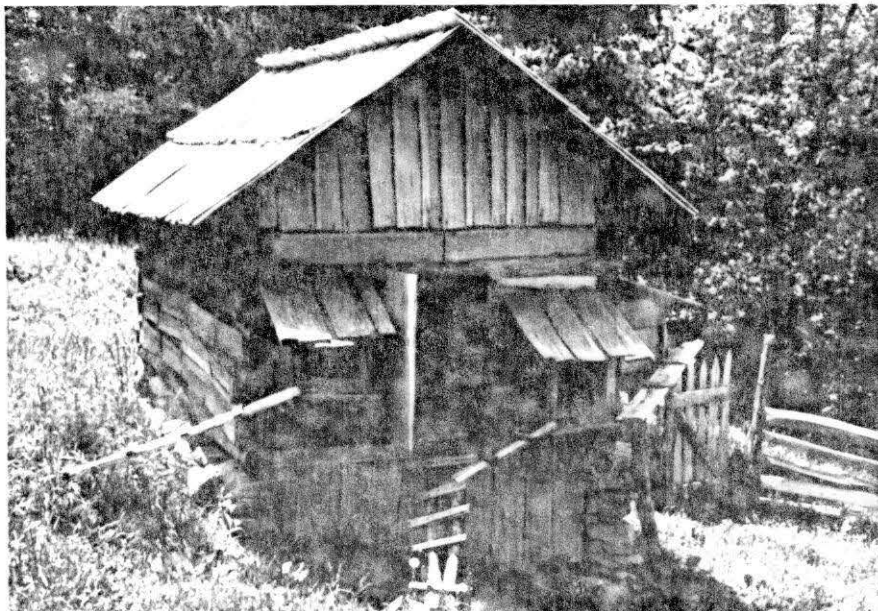
Other Outbuildings. -- Most of the problems with the remaining structures on this farm concern wood in contact with or too close to the ground. For example, the east wall of the spring house, and the skirtboards of the hen house (figure 23) are subject to decay and insect attack. However, repair or

Figure 23.--Skirt-boards of the hen house. In this case, replacement upon decay may also be easier than changing the building.

replacement of affected logs or boards will not be too costly when that occurs. The woodshed should not suffer serious problems as long as the soil is kept away from its east wall (figure 24). The stone slab at the door of the smokehouse should be moved back from the log (figure 25). Water runs over the stone and against the log.

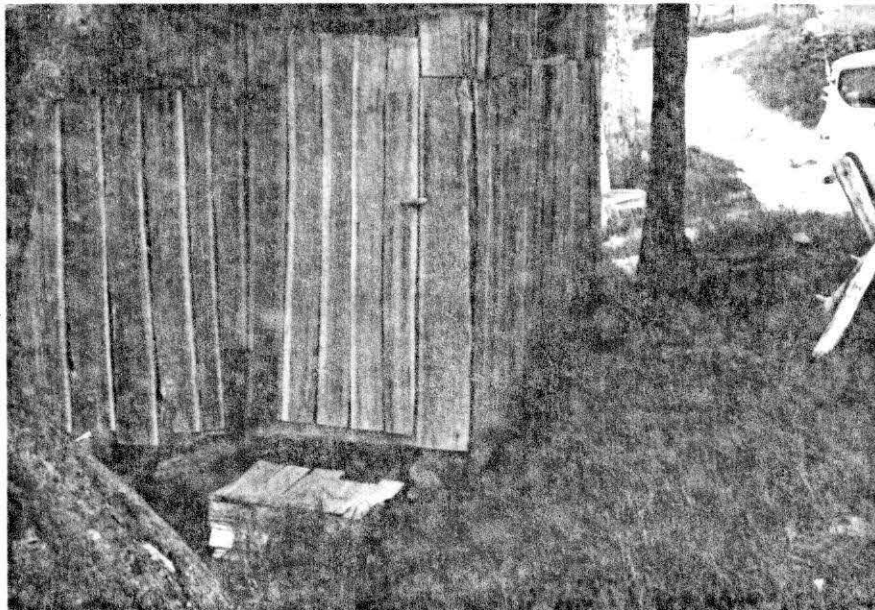
Figure 24.--Soil has been removed from in front of the woodshed to break contact with the soil. This opening must be kept free of soil, vegetation and debris.

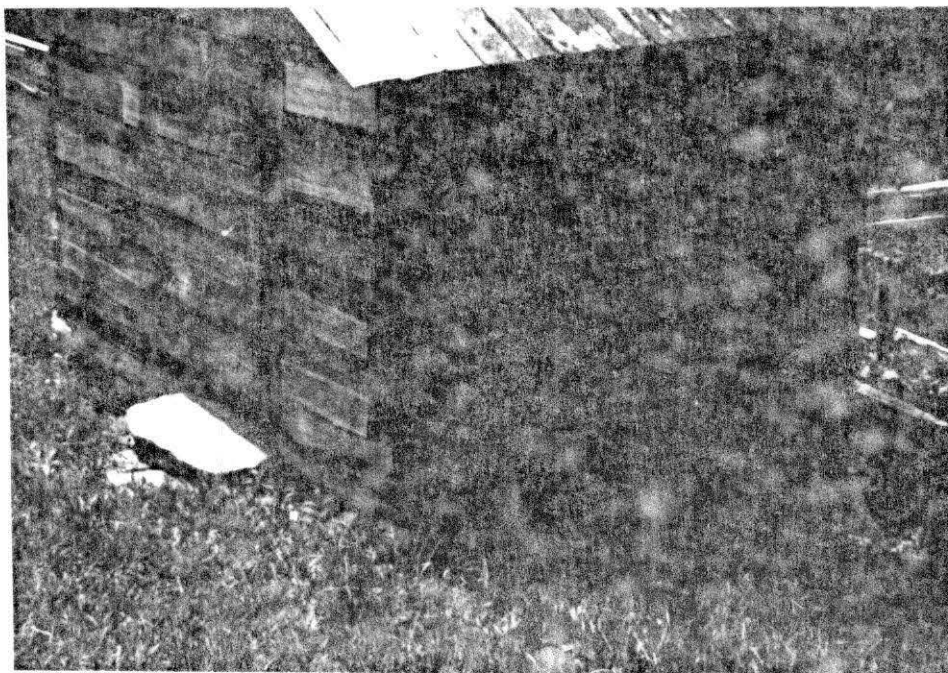
Figure 25.--Stepping stone permits surface run-off to flow against the sill. It should be moved back to provide a space between them.
